2007 DAKOTA OCCUPANT RESTRAINT SYSTEM INFORMATION

Next Generation Driver and Front-Passenger Air Bag System

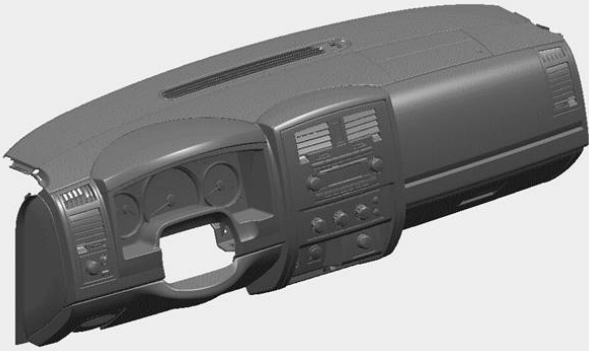
DO NOT INSTALL ADDITIONAL COMPONENTS IN ANY AREA.

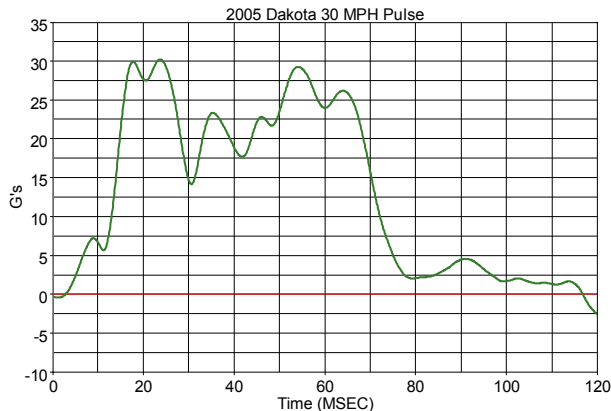
Any components added to the occupant compartment must not break loose during a 30-mph barrier impact test. A plot of the average passenger compartment (chassis) deceleration with respect to time is shown in the pulse curve below.

Further, any pulse curve information can be retrieved from the National Highway Traffic Safety Administration at the address below:
